**WALKABILITY AUDIT - INTRODUCTION**

WALKABILITY AUDIT – BY STREET SEGMENT AND STREET REALM CONDITION

# Draft North Main Street Pedestrian Realm Assessment

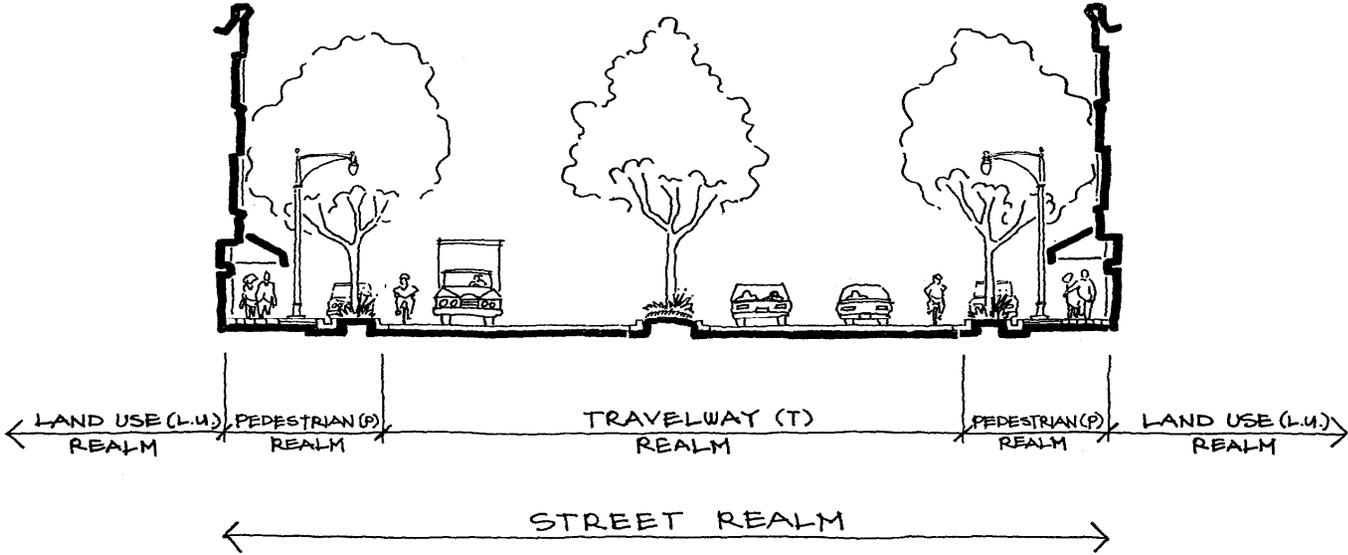
**THE STREET REALM**

To properly plan for all the elements of a corridor, it is essential to account for the four street "realms," which are the intersection realm, travelway realm (between curbs or other pavement edges), the context realm, the interface with adjacent buildings, sites, and land uses, and the pedestrian realm (pavement edge to right-of-way line),

The four realms that together comprise the thoroughfare and its context are:

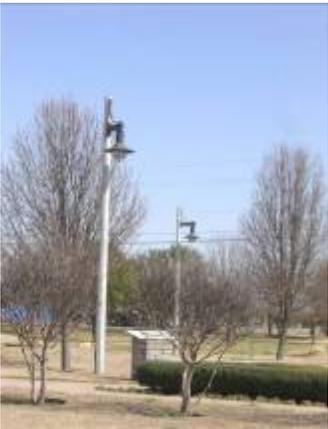
Pedestrian Lighting in Armstrong Park

Armstrong Park, which provides us with a great example of a pedestrian light pole.

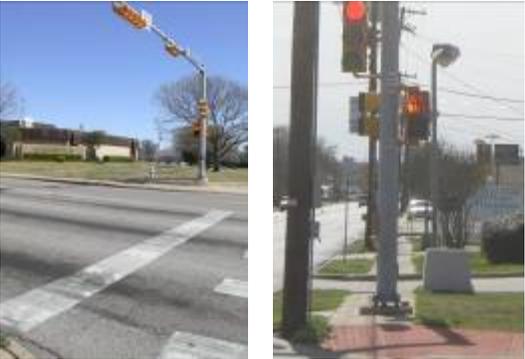
Intersection/Travelway Realm

The signalized intersection of Wheatland Road and North Main Street is defined by four ten foot travel lanes and one twelve foot turning lane on all approaches. The crosswalks are clearly marked and pedestrian crossing controls are provided for all movements. Pedestrian crossing time is adequate. Driveways near the intersection create traffic and pedestrian conflicts.

The travelway/pedestrian overlap is found in this segment only at Wheatland Road and North Main and is determined to be adequate.

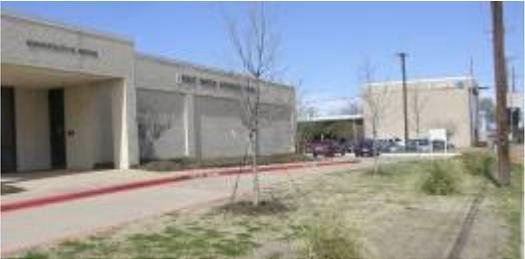
Context Realm

The predominant land use contexts in this segment of North Main is public on the east side and service and retail on the west side. These land uses are Setbacks near Wheatland are 80' to 100'. Closer to West Nance Road setbacks are reduced to 30' to 50' as pictured to the right.

The context/pedestrian overlap is stressed in this segment due to building orientation to automobiles and parking lots. The entrances to most buildings in this section of the corridor are oriented toward parking lots and are not accommodating to pedestrian traffic.

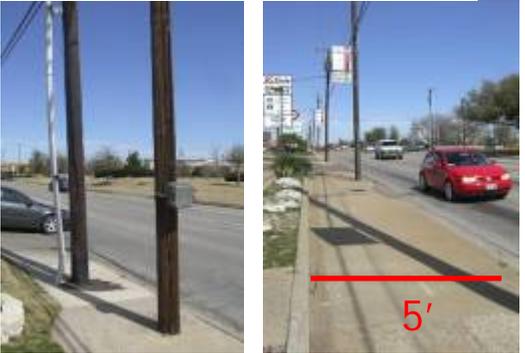
Pedestrian Realm

Other conditions include: poor sidewalk concrete condition, frequent driveways with steep side slopes, uneven joints, poor lighting and no buffer with traffic lane. These conditions are most evident on the west side of the street. The East side of the street is dominated by

The pedestrian realm is typically provided adjacent to the street in the form of a 4' to 5' concrete sidewalk. The presences of electric utility poles at an average distance of 140' (some being much closer as pictured) create obstructions in the already undersized sidewalk.

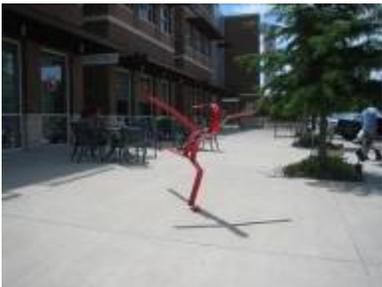
Public Art at Mixed-Use Center

The context/pedestrian overlap is embraced in the 100 North Main area, with public art as the joining element. Other areas do a good job of addressing the street with proper front door locations and pedestrian level signage.

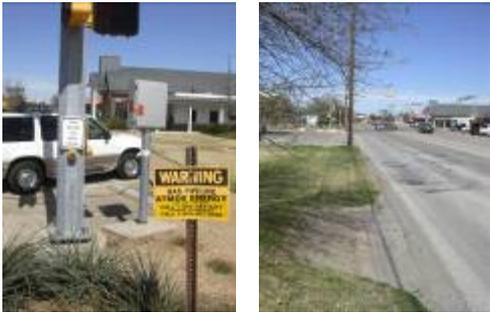
Intersection/Travelway Realm

The signalized intersection of Center Street and North Main Street is defined by four ten foot travel lanes and one twelve foot turning lane on all approaches. The east bound approach also has a shared through or left lane. The crosswalks are clearly marked and pedestrian crossing controls are provided for all movements. Pedestrian crossing time is adequate. Driveways from the southwest quadrant interfere with the intersection, thus creating traffic and pedestrian conflicts.

The travelway/pedestrian overlap is found in this segment only at Center Road and North Main. The pedestrian control buttons are poorly positioned here, but crossing times are adequate.

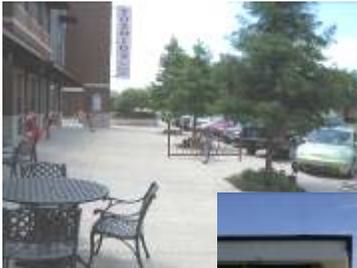
Context Realm

Land uses in the segment vary from office, service, day care, youth center, retail, restaurant and public. This is truly a mixed-use segment. The mix of uses means the pedestrian realm will be used by many, including children. Building setbacks vary from 80' at 210 Main to 20' at 215 Main. The new mixed-use center at 100 Main establishes a setback of 44'. The presence of on street parking in-front of the mixed use center and in-front of 113 North Main and 215 North Main add to the urban environment and work to buffer the sidewalk from the travel lanes. However, the placement of "temporary" storage buildings or other visual blight in the context realm detracts from the pedestrian experience.

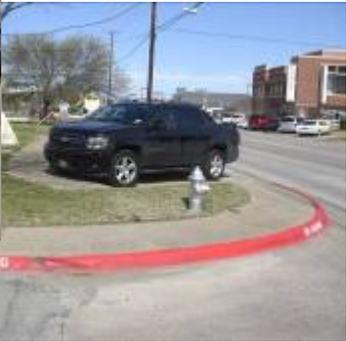
Pedestrian Realm

The pedestrian realm varies from nearly perfect conditions in front of 100 North Main to poor conditions adjacent to 103 North Main. Of greatest concern is the lack of wheelchair ramps at the intersection of Freeman Road. Secondly,

the sidewalk ends north of 113 North Main and does not begin until the intersection with Center Street.

Other conditions include: poor sidewalk concrete condition, frequent driveways with steep side slopes, uneven joints, poor lighting and no buffer with traffic lanes.

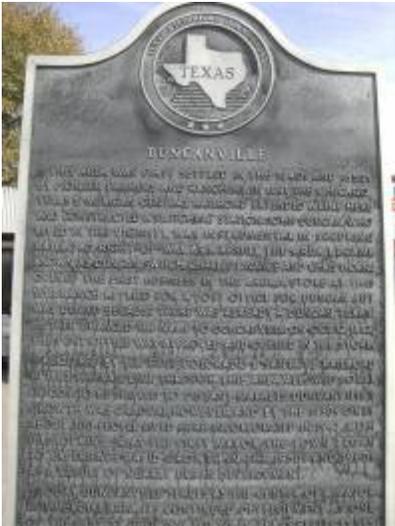
The importance of the railroad on the development and history of Duncanville is noted in a Texas Historical Commission marker at the intersection of East Davis and Main Street. The location and orientation of the marker makes it difficult to be read by pedestrians and/or drivers. Geometric improvements at East Davis

could not only improve visibility of this historical marker, but could make pedestrian travel safer and easier.

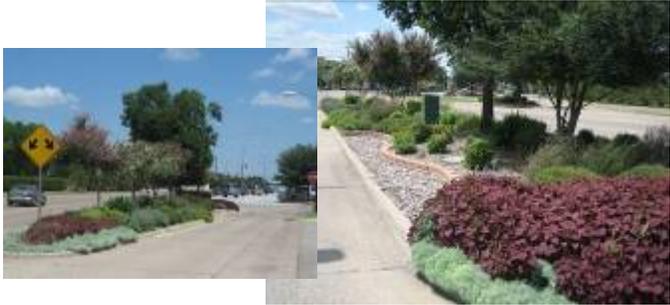
Intersection/Travelway Realm

The signalized intersection of East Davis Street and North Main Street is defined by four ten foot travel lanes and one twelve foot turning lane on the North and South approaches. The crosswalks at this intersection are in need of re-striping. Pedestrian crossing controls are provided crossing main on the south side only. These buttons are positioned in a poor location on the east side. Pedestrian crossing time is adequate. Traffic control devices at this intersection are old and are being suspended by guide wire.

The travelway/pedestrian overlap in this segment is good except for the wide and poorly defined driving isle in the angled parking lot.

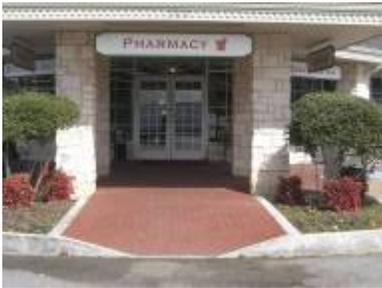
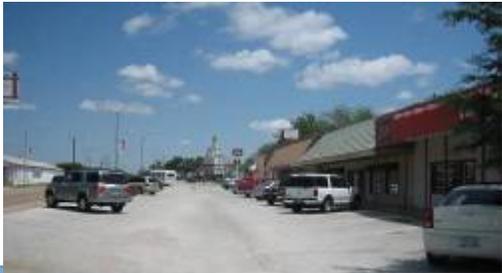
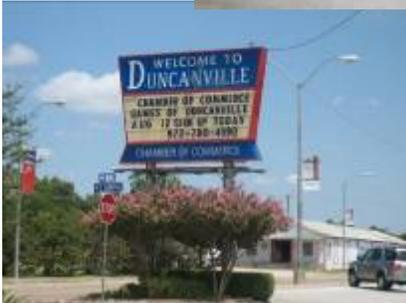
Pedestrian Realm

The pedestrian realm for a majority of this segment is adjacent to the building facades along a 5' path, which is buffered by angled parking. Connections from the building fronts to the intersection crosswalks are poorly defined or nonexistent.

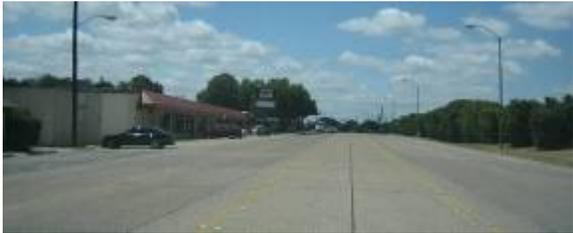
Intersection/Travelway Realm

The signalized intersection of Camp Wisdom Road and North Main consist of four travel lanes and one left turn lane in all approaches. Additionally, the north bound approach of North Main has a right turn slip lane and the eastbound approach of Camp Wisdom has a right turn only lane. Pedestrian crossing control devices are provided for all movements except on the west side of the intersection for the north to south movement. Pedestrian are restricted from performing this movement. The travelway realm from East Davis to Carder Road widens to accommodate at twelve foot two way left turn lane. Perceivably, this was added to accommodate the multiple driveways found in this section and to make navigating into the 90 degree parking easier.

The travelway/pedestrian overlap in this segment is stressed by the widening of the cross-section and general lacking of pedestrian accommodations.

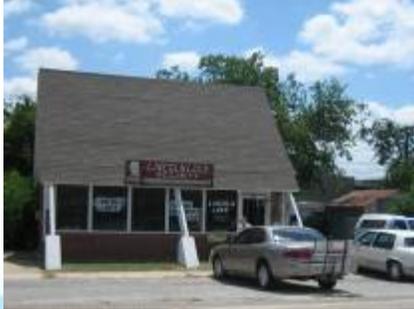
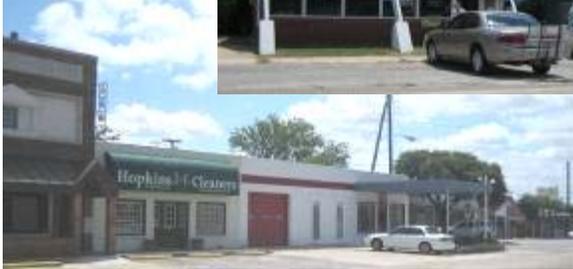
Context Realm

The context/pedestrian overlap in this segment is extremely limited due to poorly positioned 90 degree off-street parking. Front doors are typically related to the street and could provide a nice entrance for pedestrians.

Beyond the first few buildings north of East Davis Street, the corridor begins to loose its main street urban form. Fewer structures share a common wall, parking, driveways and sidewalks in this segment of the corridor. The set-back at the East Davis intersection is 22'. It opens up to 30' at 418 North Main and further north at 716 North Main the setback is 70'. The land uses in this section also depart from the typical main street uses, turning to more auto oriented uses, such as filling stations and auto repair shops. Vacant, abandoned and underutilized lots are frequent. Nonetheless,

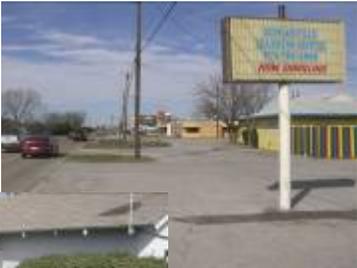
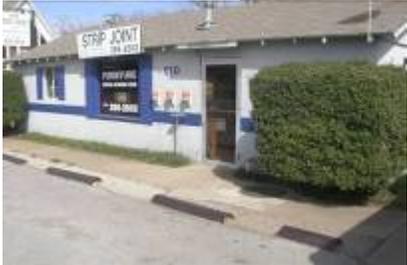
Pedestrian Realm

The pedestrian realm in this segment is distressed or non-existent. Sidewalks are absent from the corner of East Davis and North Main Street. Sidewalks are present sporadically and in

an unconnected fashion from 418 North Main to 624 North Main, before ending completely at 624 North Main. The recent completion of the QT filling station has added a 5' sidewalk with wheel chair ramps at the corner of Camp Wisdom Road.

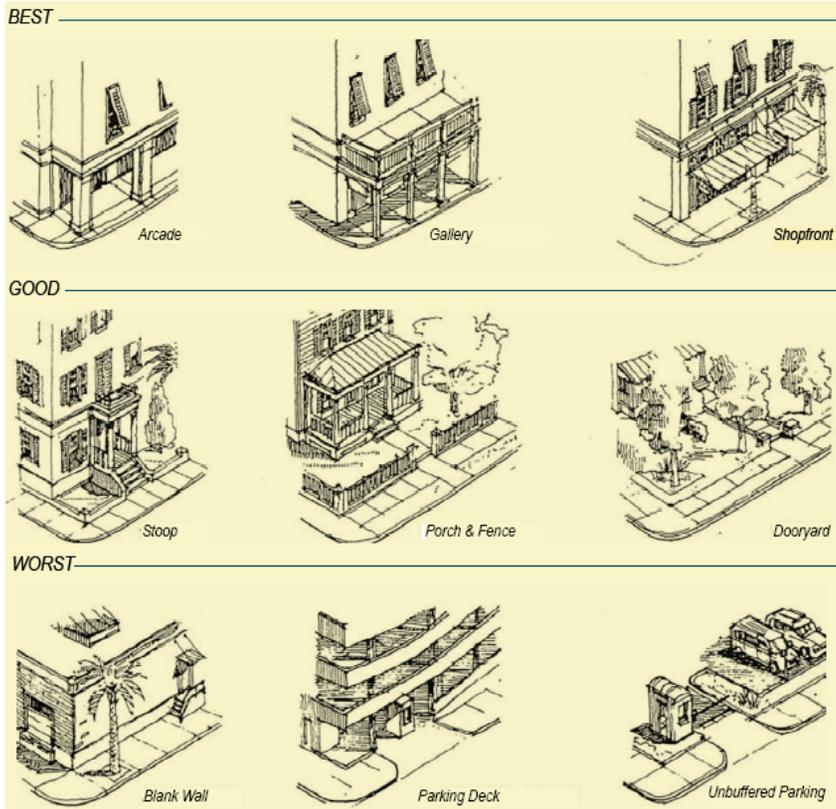
Many studies have uncovered the attributes of an interesting streetscape. There is consensus that one of the most important aspects is the frontage. A frontage is the way in which a building meets the sidewalk on its first floor — i.e. the stimulus that the pedestrian walks past. There is a gradation regarding what frontages are most attractive and which are least. The most attractive by far are shopfronts, followed by dwellings with

short setbacks equipped with stoops or porches, then followed by houses with deep common lawns (which are neutral). Finally there are the progressively negative blank walls, parking garages and open parking lots. There are examples of all these types of frontages along the North Main Street Corridor. However, buildings dating from the 60's to present typically ignore the importance of street

*This diagram shows typical pedestrian frontages, ranging from the most pedestrian friendly to the least pedestrian— friendly.*
